# DASSOXTR FIRE TEST REPORT

SFM 12-7A-1 TESTING ON EXTERIOR WALL ASSEMBLY CONTAINING EPC-SID18-137TG-PP  
CLASSIC ESPRESSO 1 IN. X 7 IN. RAINCLAD SIDING SHIPLAP FUSED BAMBOO DECK BOARDS

J6810.05-121-24-R0

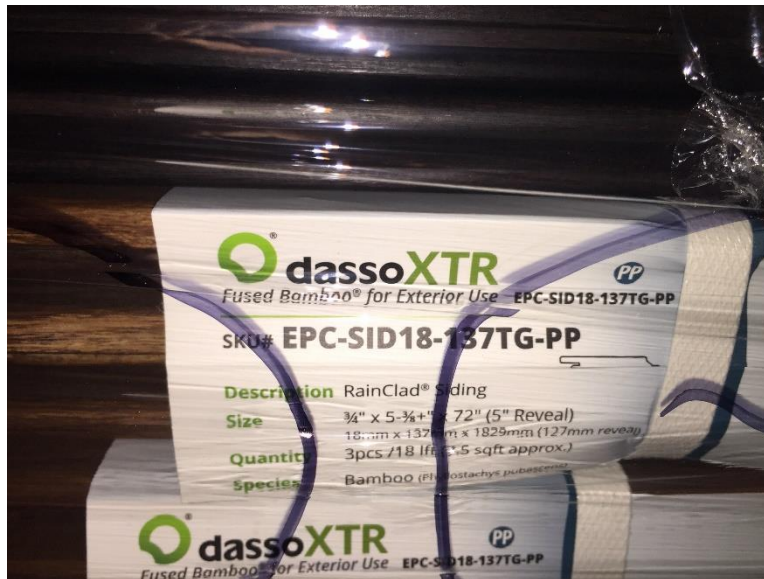
**Photo No. 1**  
**Sample Identification**

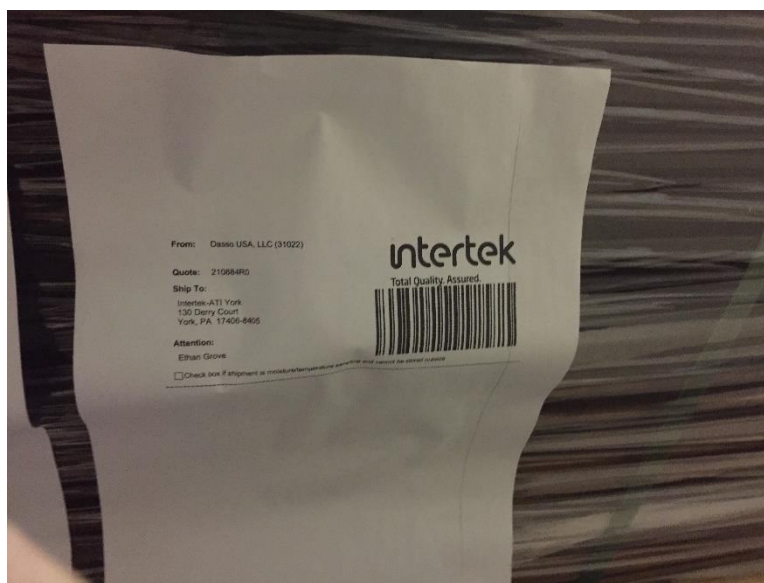
**Photo No. 2**  
**Sampling Labeling**

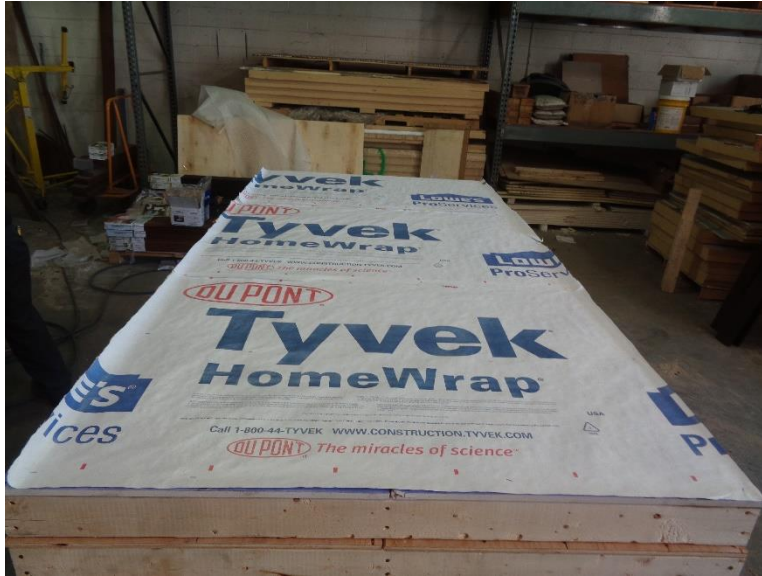
**Photo No. 3**  
**Construction of Test Assembly**

The overall dimensions of the test assembly are 4 feet wide by 8 feet high. Below is a detailed description of the components in the assembly:

2 in. x 4 in. x 8 ft. 4 SPF dimensional lumber was used as the framing. The studs were placed on 24 in. centers. This framing was secure to a header and sill board of the same lumber and secured with 3-5/8 in long framing nails.

1/2 in. thick National Gypsum Gold Bond® eXP® exterior gypsum sheathing, meeting the requirements of ASTM C1177, was installed vertically across the full exterior surface of the assembly. A vertical joint was utilized on the center vertical stud. The gypsum sheathing was fastened to the wall framing with #6 x 1-1/4 in. long, bugle head, self-drilling screws with a nominal spacing of 8 in. around the board perimeter and 12 in. in the field.

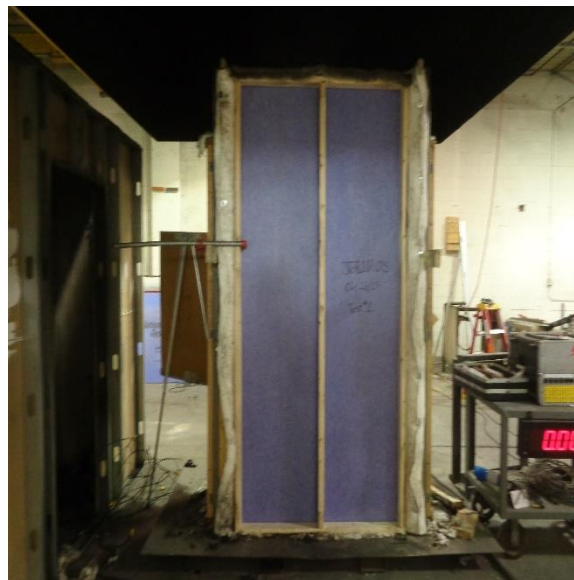
**Photo No. 4**  
**Complete Assembly (Interior)**

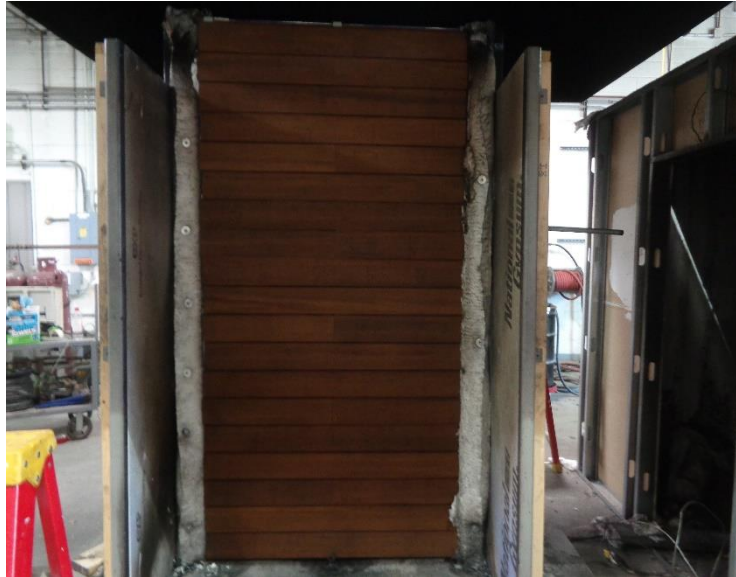
**Photo No. 5**  
**Complete Assembly (Exterior)**

1 in. wide x 1/2 in. thick wood battens were installed first on the assembly. 6 in. wide DassoXTR EPC-SID18-137TG-PP Classic Espresso was utilized as the cladding for the assembly. Cisen Sheathing system was used to secure the cladding to the assembly. Two 1 in. long #12 pan head 316-grade stainless steel screw were used per clip. Clips were not placed greater than 24 in. on center and placed at each siding joint.

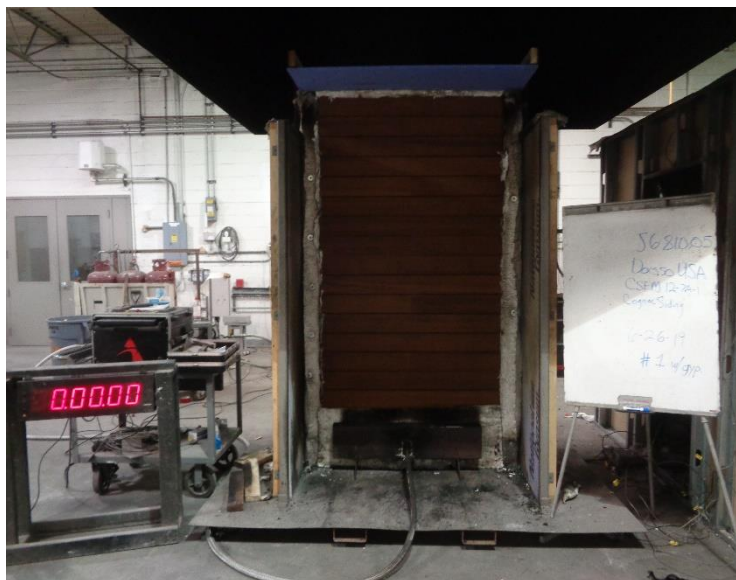
**Photo No. 6**  
**Test Assembly (Pre-test)**

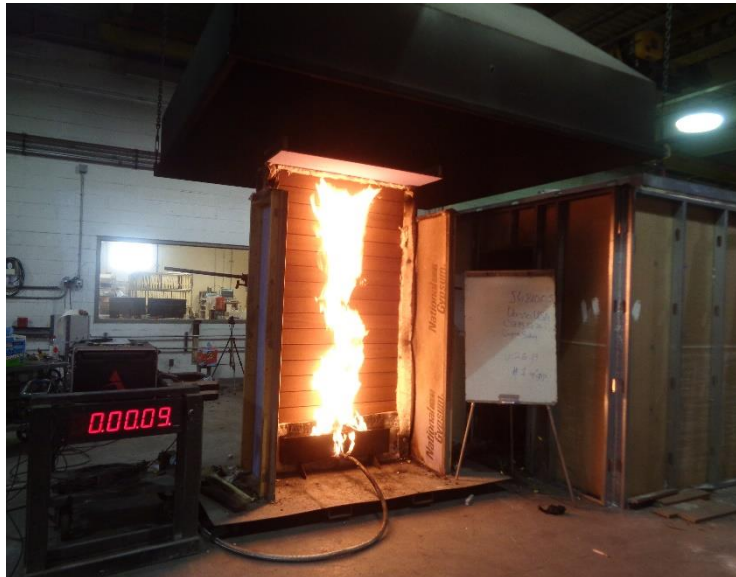
**Photo No. 7**  
**Ignition of Burner**

The test specimen is installed into the fixture and centered underneath of the combustion collection system. The ignition source for the test is a gas burner with a 4 inch by 39 inch diffusion adapter filled with a minimum 4-inch layer of Ottawa sand. The top surface of the burner through which the gas is applied is positioned 12 inches above the floor. The burner is centered inside of the fixture and is placed in contact with the surface of the specimen. The gas supply to the burner is C.P. grade propane (99 percent purity). The burner is set to produce a gross heat output of  $150 \pm 8$  kW for ten minutes. The flow rate is metered throughout the test. The gas burners are controlled with mass flow meters to control the volume of gas to match the heat outputs of the standard. At the end of the ten-minute burn period, the burner is shut off and all instrument readings are stopped. Post-test observations are made for an additional 60 minutes or until all evidence of combustion is no longer visible. The test procedure is repeated to a total of three total tests.

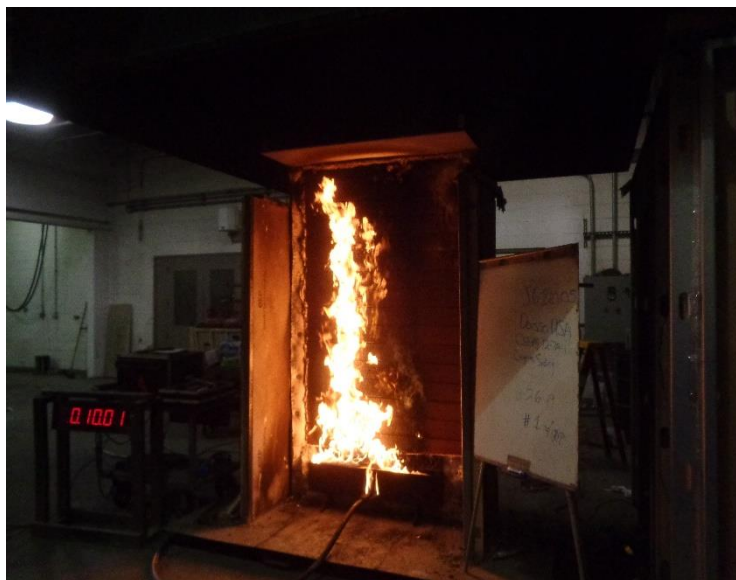
**Photo No. 8**  
**Flaming after Burner is Extinguished**

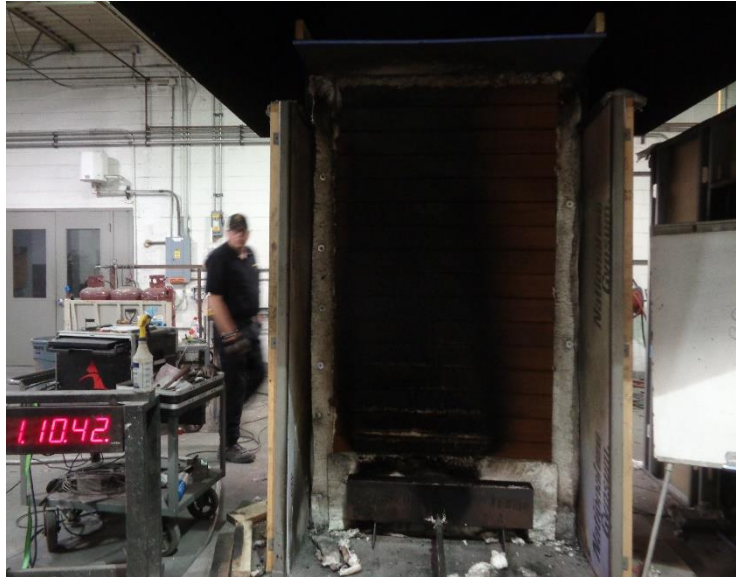
**Photo No. 9**  
**Post-test Exterior**

TEST REQUIREMENTS	TEST RESULTS	PASS/FAIL
Absence of flame penetration through the wall assembly at any time.	Flame penetration through the assembly was not observed during the full duration of the three tests.	PASS
Absence of evidence of glowing combustion on the interior surface of the assembly at the end of the 70-minute test.	No Evidence of glowing combustion on the interior surface of the assembly at the end of the 70-minute duration for all three tests was present.	PASS

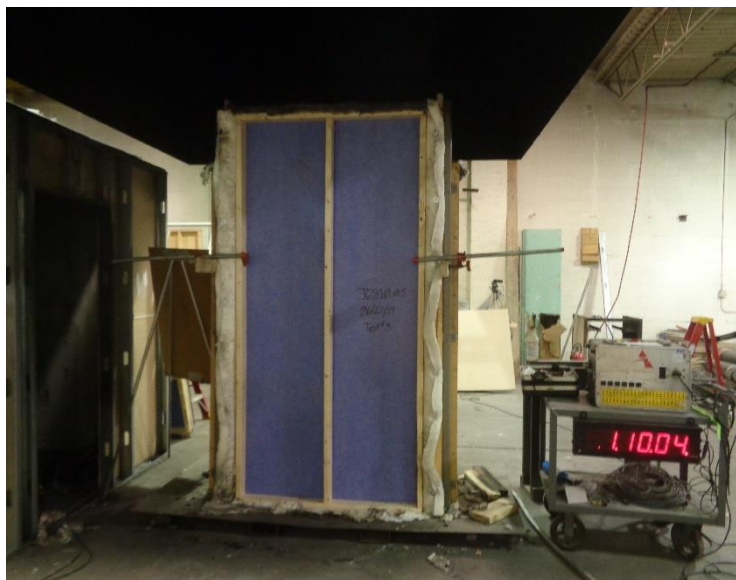
**Photo No. 10**  
**Post-test Interior**

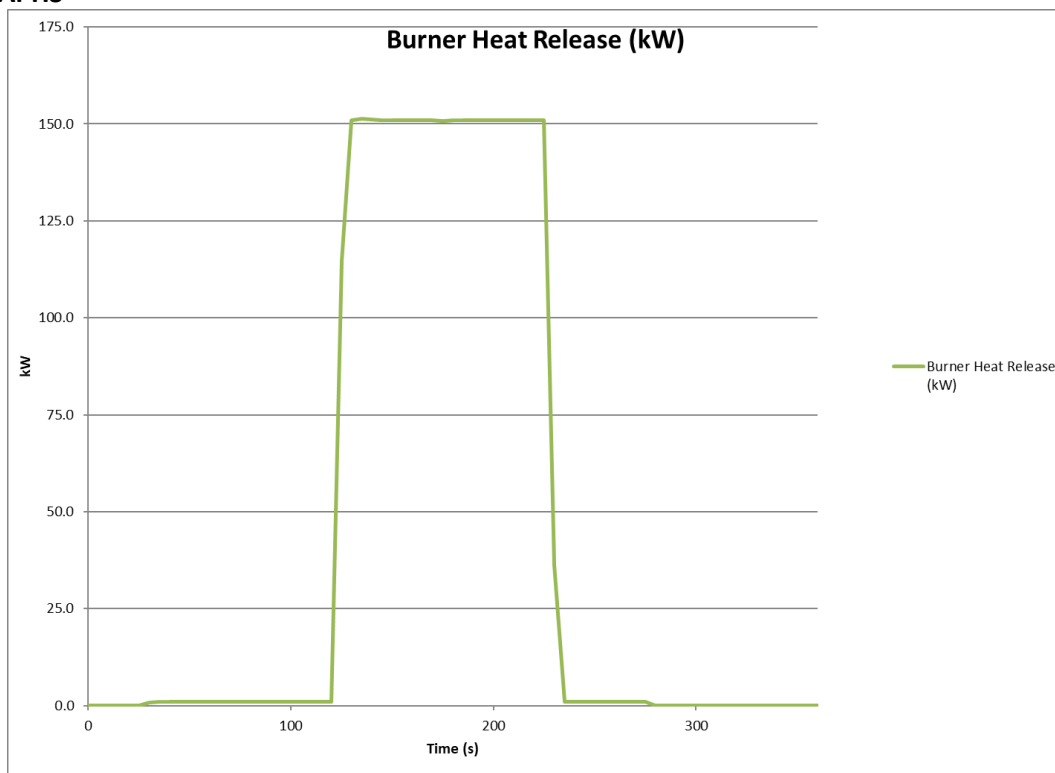
**Graph No. 1**  
**Burner Output Verification Data**

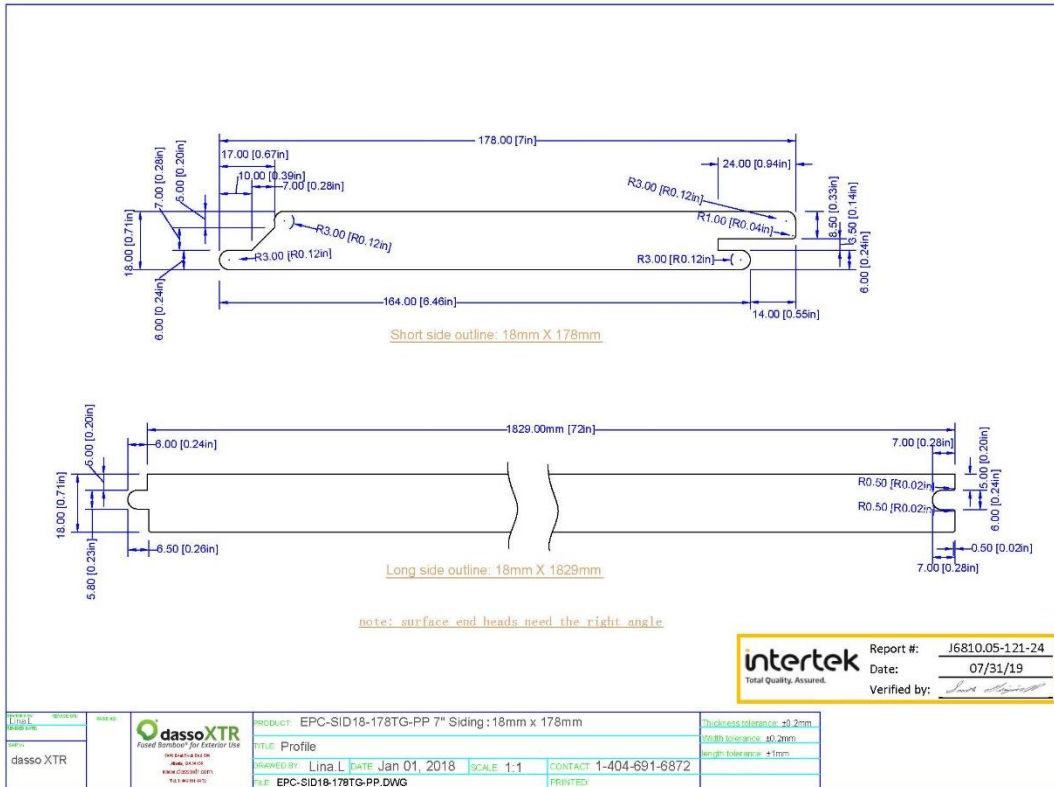
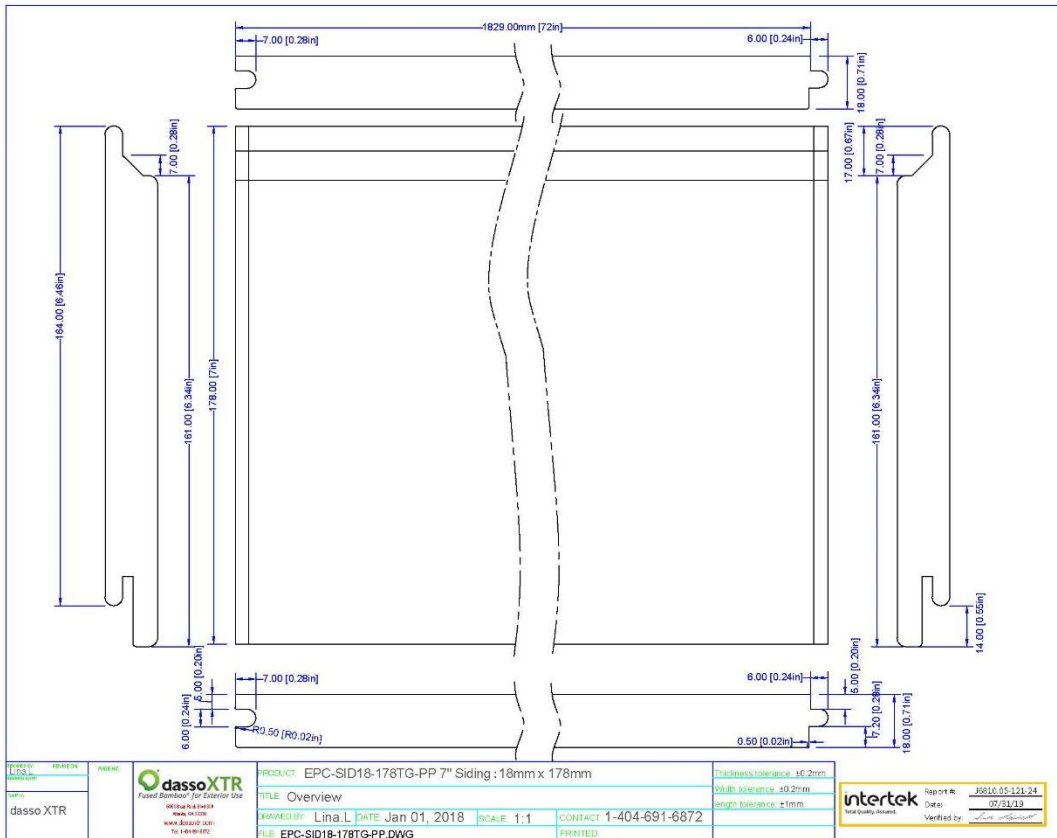
The test specimen drawings which follow have been reviewed by Intertek B&C and are representative of the test specimen(s) reported herein. Test specimen construction was verified by Intertek B&C per the drawings included in this report. Any deviations are documented herein or on the drawings.
