# DASSOXTR FIRE TEST REPORT

SFM 12-7A-4A TESTING ON EPC-DK20-G2-PP EPIC COGNAC 1 X 6 FUSED BAMBOO DECK BOARDS

J6810.04-121-24-R0

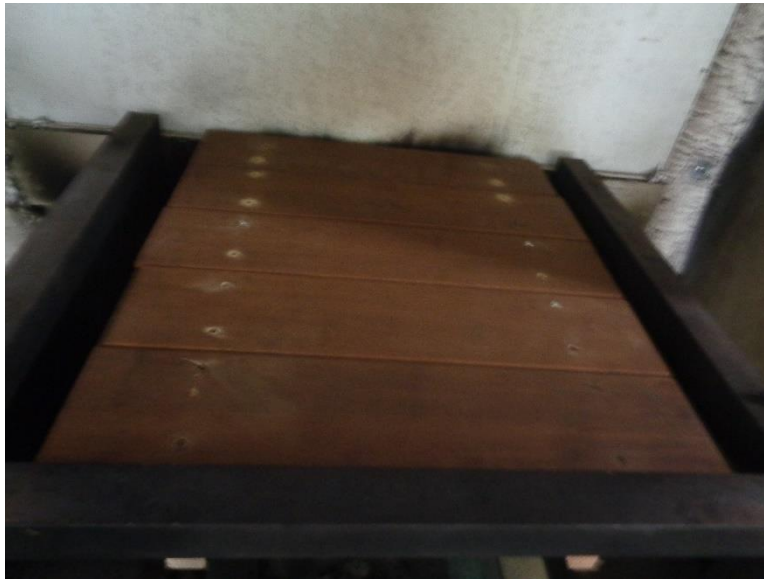
**Photo No. 1**  
**Complete Assembly (Above Deck)**

The overall dimensions of the test assembly are 4 feet wide by 84 inches high. Below is a detailed description of the components in the assembly:

DassoXTR, EPC-DK20-G2-PP Epic Cognac 1 x 6 fused exterior bamboo deck boards were cut to 24 in. long lengths. The deck boards were secured to the joists using Cisen winged deck fasteners system. This system used a #7 x 1-3/5 in. grade 304 stainless steel screws and wing clips to secure the deck boards to the wood joists. The deck fastener system created a 5/16 in. space between each deck board.

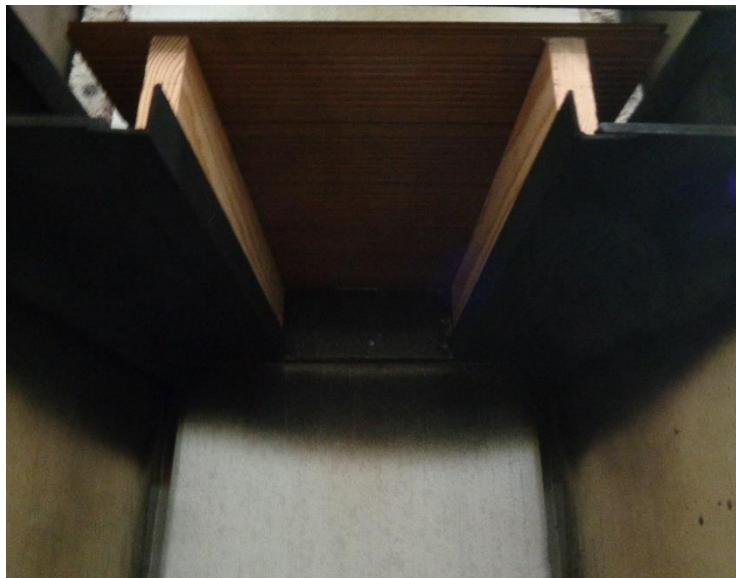
**Photo No. 2**  
**Complete Assembly (Below Deck)**

2 x 6 Douglas fir dimensional lumber was cut to 27-1/8 in. Two identical pieces were cut to simulate two joists for the deck boards to attached to.

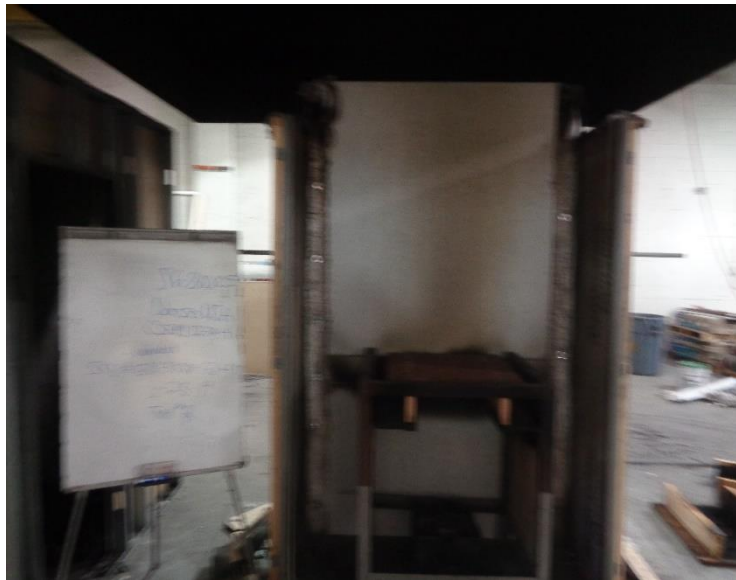
**Photo No. 3**  
**Test Assembly (Pre-test)**

For the under-deck flame test, the ignition source for the under-deck test is a gas burner with a 12 inch by 12 inch diffusion adapter filled with a minimum 4-inch layer of Ottawa sand. The top surface of the burner through which the gas is applied is centered and positioned 27 inches below the surface of the deck. The gas supply to the burner is C.P. grade propane (99 percent purity). A burner verification test is run prior to the under-deck test. Verification test involves using oxygen consumption calorimeter to confirm the output. The burner is set to produce a gross heat output of  $80 \pm 4$  kW for three minutes. The gas burners are controlled with mass flow meters to control the volume of gas to match the heat outputs of the standard. After the verification test, the specimen is installed into the fixture and the diffusion burner is placed. The collection hood exhaust duct blower is turned on and an initial flow is established. Burner is centered underneath the test deck and then ignited at a fuel flow rate that is known to produce 80 kW of heat output and maintained for 3 minutes. When the burner is shut off, post-test observations are documented for 40 minutes.

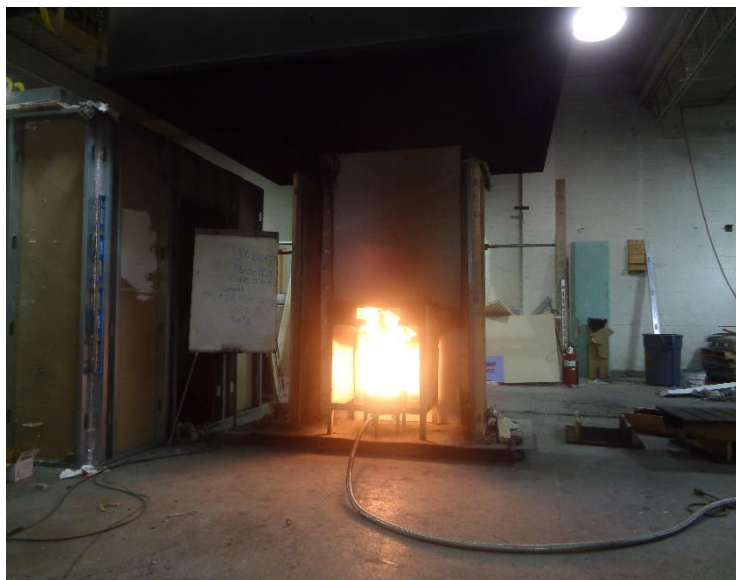
**Photo No. 4**  
**Ignition of Burner**

TIME (Min:Sec)	OBSERVATIONS
00:00	Ignition of burner. Heat output set at 80 kW
00:48	Ignition of the underdeck.
01:04	Ignition of the deck surface.
03:00	Burner extinguished.
04:16	Flaming on the deck surfaces stop emitting from the surfaces.
43:00	End of test and observations.

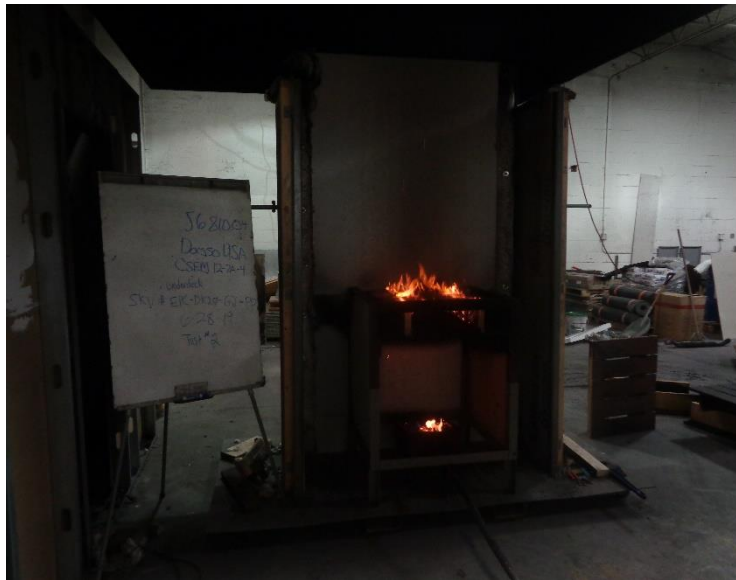
**Photo No. 5  
Burner Off**

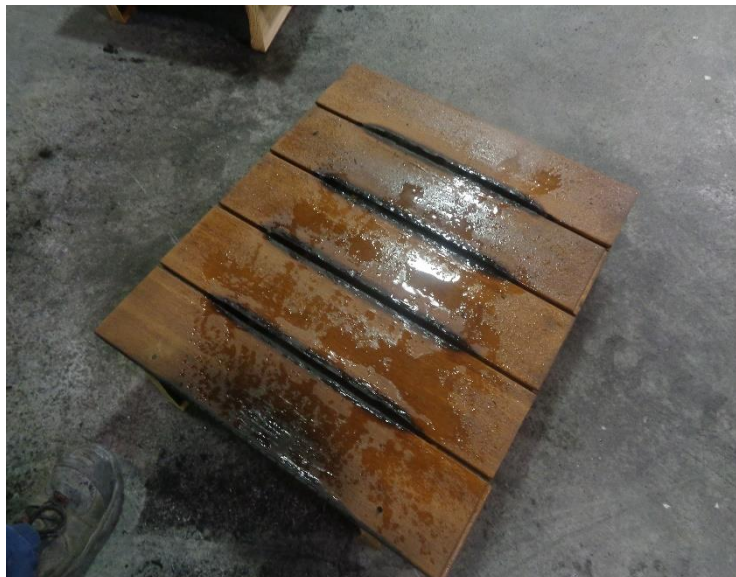
**Photo No. 6  
Post-test Above Deck**

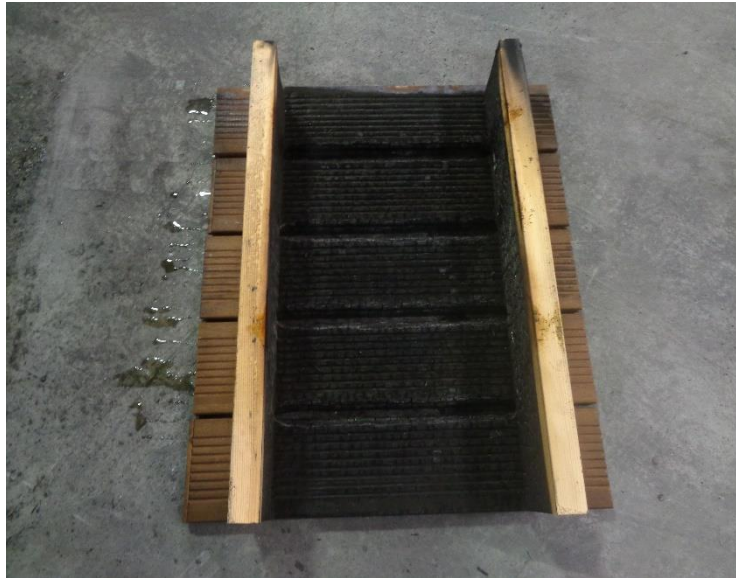
**Photo No. 7**  
**Post-test Below Deck**

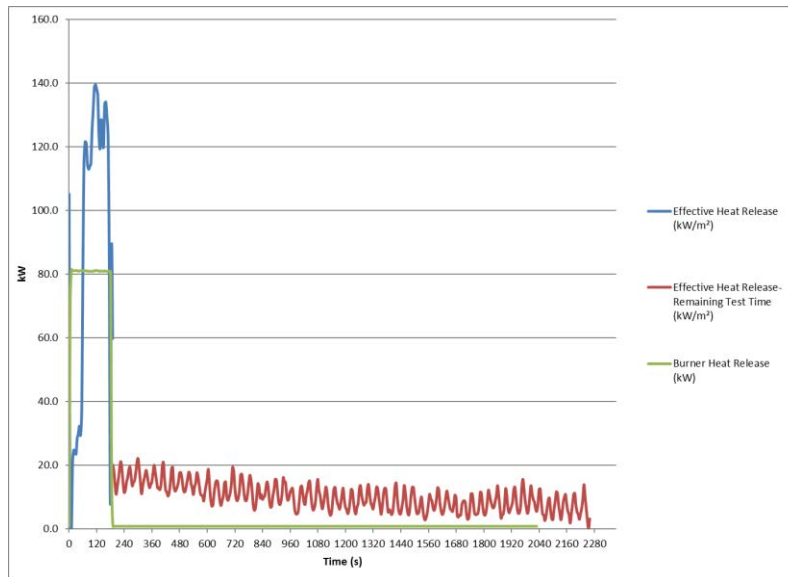
**Graph No. 2**  
**Under-deck Test #1 Heat Release Data**

TEST REQUIREMENTS	TEST RESULTS	PASS/FAIL
Effective net peak heat release rate of less than or equal to 25 kW/ft <sup>2</sup> (269 kW/m <sup>2</sup> )	Effective net peak heat release rate of: Sample #1: 158.1 kW/m <sup>2</sup> Sample #2: 137.8 kW/m <sup>2</sup> Sample #3: 150.3 kW/m <sup>2</sup>	<b>PASS</b>

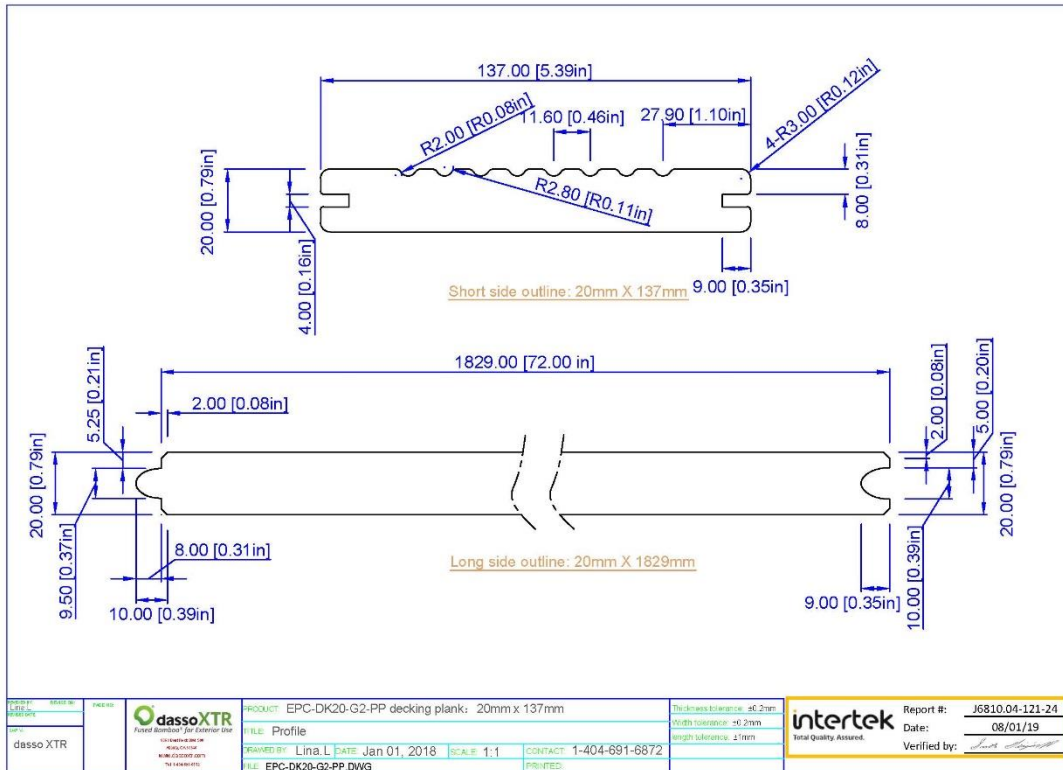
The test specimen drawings which follow have been reviewed by Intertek B&C and are representative of the test specimen(s) reported herein. Test specimen construction was verified by Intertek B&C per the drawings included in this report. Any deviations are documented herein or on the drawings.
