FIRE TEST REPORT

SFM 12-7A-4A TESTING ON XTR-DK20-G2-PP FUSED BAMBOO DECK BOARDS

J6810.01-121-24-R0

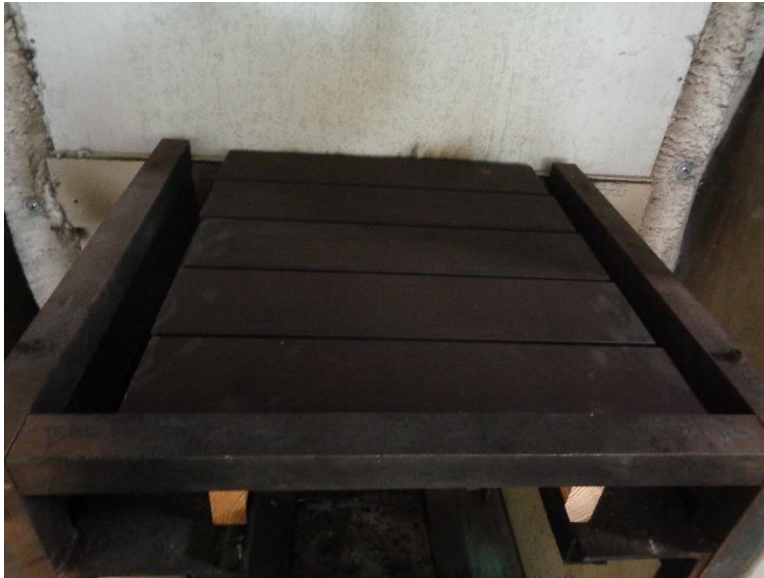
Photo No. 1
Complete Assembly (Above Deck)

The overall dimensions of the test assembly are 4 feet wide by 84 inches high. Below is a detailed description of the components in the assembly:

Dasso USA, LLC XTR-DK20-G2-PP fused bamboo deck boards were cut to 24 in. long lengths. The deck boards were secured to the joists using Cisen winged deck fasteners system. This system used a #7 x 1-3/5 in. grade 304 stainless steel screws and wing clips to secure the deck boards to the wood joists. The deck fastener system created a 5/16 in. space between each deck board.

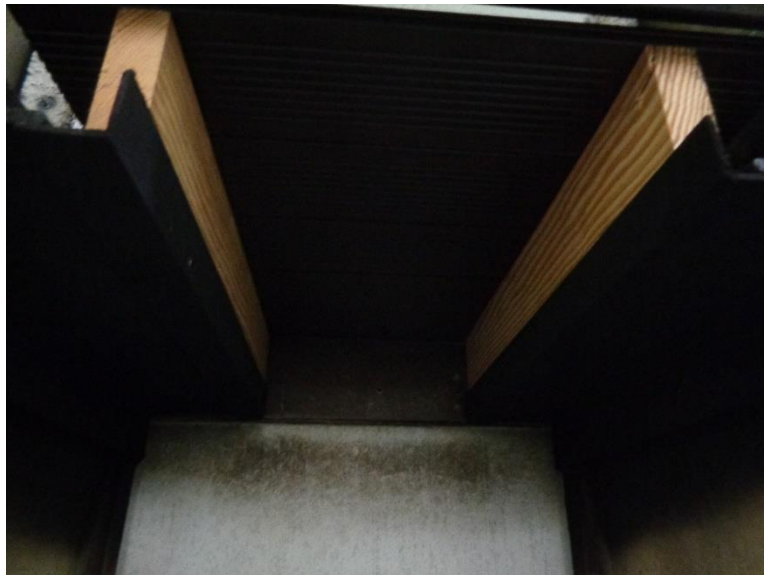
Photo No. 2
Complete Assembly (Below Deck)

2 x 6 Douglas fir dimensional lumber was cut to 27-1/8 in. Two identical pieces were cut to simulate two joists for the deck boards to attached to.

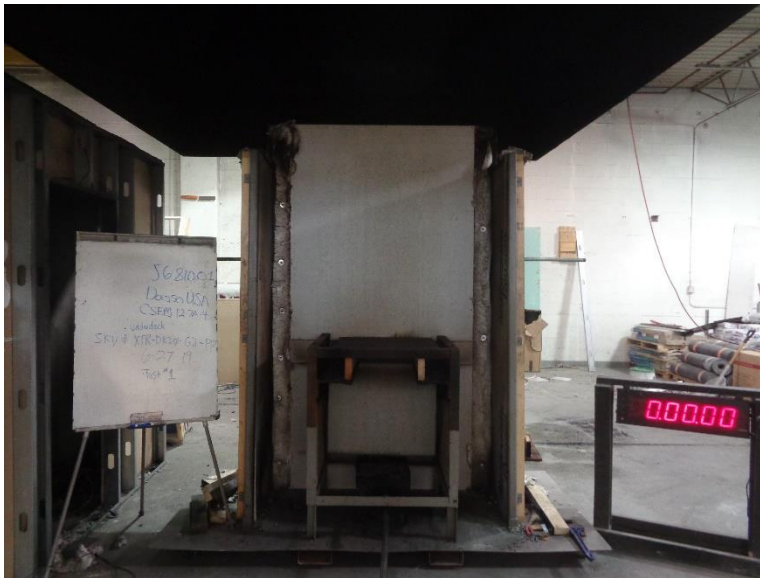
Photo No. 3
Test Assembly (Pre-test)

For the under-deck flame test, the ignition source for the under-deck test is a gas burner with a 12 inch by 12 inch diffusion adapter filled with a minimum 4-inch layer of Ottawa sand. The top surface of the burner through which the gas is applied is centered and positioned 27 inches below the surface of the deck. The gas supply to the burner is C.P. grade propane (99 percent purity). A burner verification test is run prior to the under-deck test. Verification test involves using oxygen consumption calorimeter to confirm the output. The burner is set to produce a gross heat output of 80 ± 4 kW for three minutes. The gas burners are controlled with mass flow meters to control the volume of gas to match the heat outputs of the standard. After the verification test, the specimen is installed into the fixture and the diffusion burner is placed. The collection hood exhaust duct blower is turned on and an initial flow is established. Burner is centered underneath the test deck and then ignited at a fuel flow rate that is known to produce 80 kW of heat output and maintained for 3 minutes. When the burner is shut off, post-test observations are documented for 40 minutes.
