Project #G102336314  
Letter Report #102336314COQ-002

**Subject: Findings Letter Report 102336314COQ-002**

Intertek has conducted non-standard testing for Dasso USA on their XTR Fused Bamboo decking product in accordance with CAN/ULC S107-10 "Standard Methods of Fire Tests of Roof Coverings". Intertek conducted one Spread of Flame, Intermittent Flame Exposure, and Burning Brand Test as requested for research and development purposes.

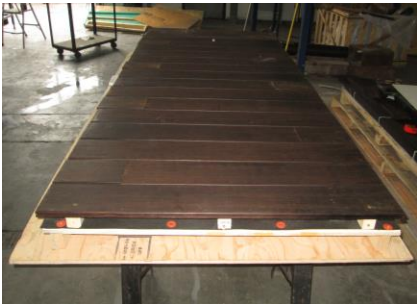
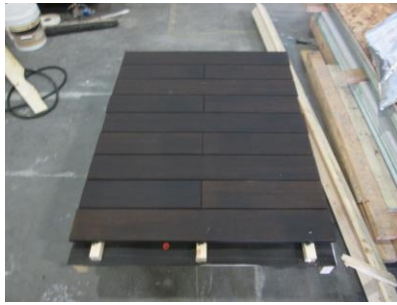
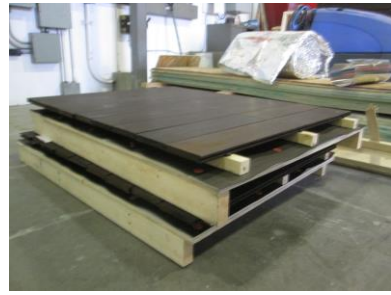
**Decking Installation**

Hardie Board was installed onto the deck surface (to simulate a non-combustible base) with construction screws placed 24 inches on center. Generic underlayment #30 complying with ASTM D4869 Type II was applied on top of the Hardie Board and fastened using cap nails with spacing at 12 inches (304.8mm) on center. Dasso XTR Fused Bamboo roofing product was installed onto 2x2 SPF white lumber battens spaced 16 inches (406.4mm) on center. Battens were installed four inches in from each edge and at the center of the test deck (see installation photos). Dasso XTR Fused Bamboo roofing product was installed in accordance with the manufacturers' installation instructions.

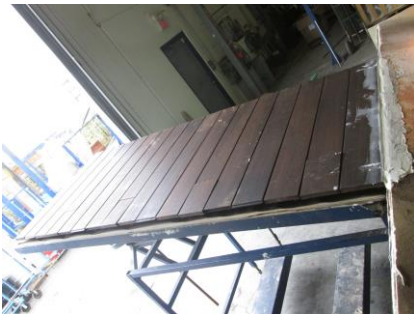
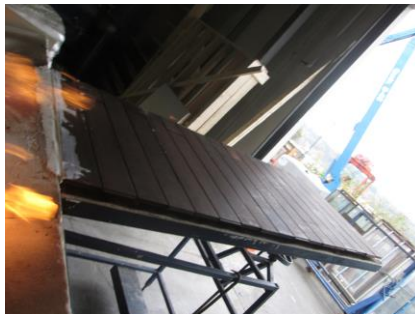
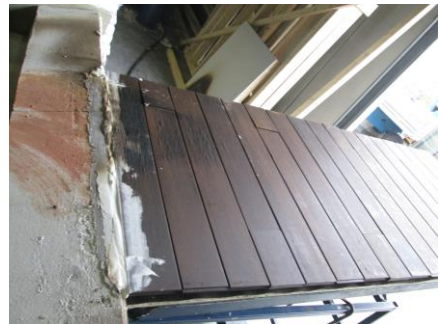
**Spread of Flame Test**

Time (min:sec)	Distance (ft)	Observations
0:00	N/A	Start of test
3:22	N/A	Wrinkling on first panel
7:00	N/A	Minor wrinkles forming on second and third panel. Slight discolouration (darkening) on first panel.
10:00	N/A	Specimen stable. End of test.

**Acceptance Level: Class "A" – No flaming beyond deck extents or past 1830mm during the Spread of Flame Test.**

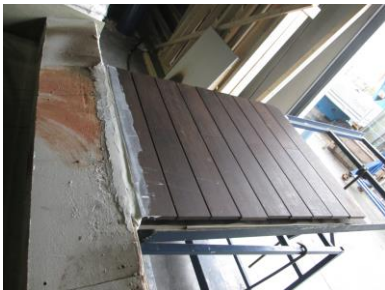
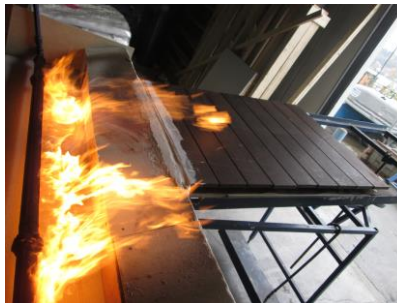
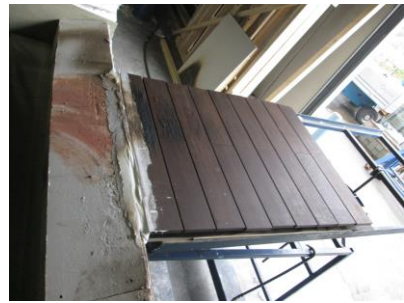
**Intermittent Flame Exposure Test**

After Test Observations: No smoke, glow or flaming on test deck. Sample is stable with no reactions.

**Acceptance Level: Class “A” – No flaming on underside of deck, and no reactions after test completion**

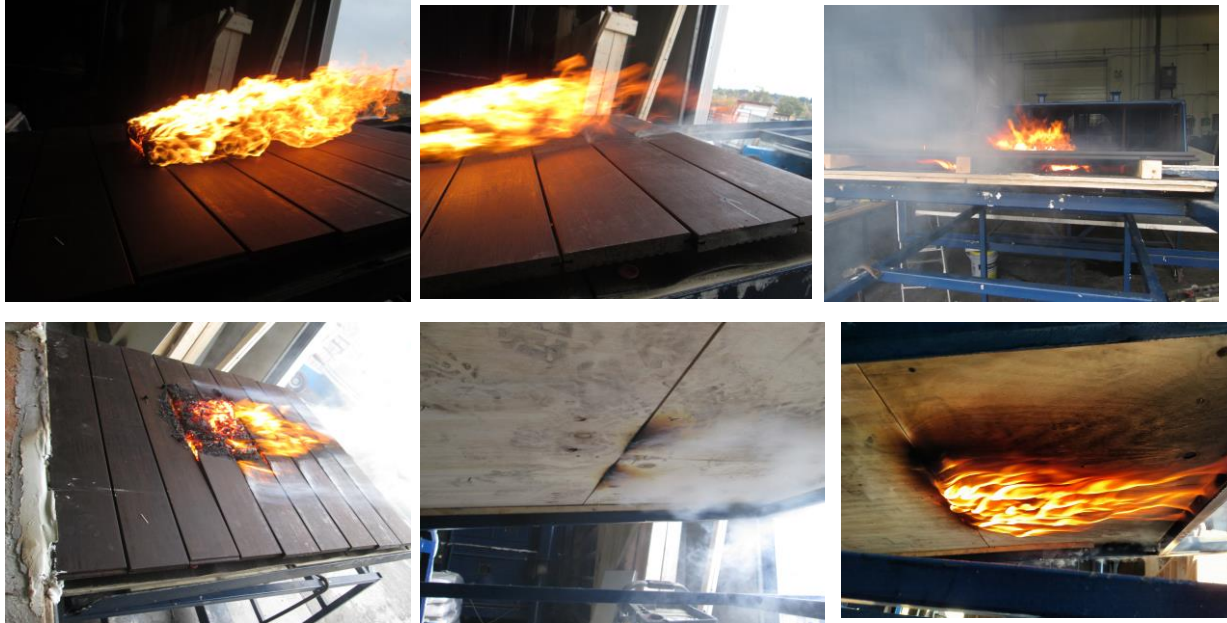
Burning Brand

TIME (min:sec)	OBSERVATIONS
0:00	Start of test. Brand placed on deck.
3:17	Flaming between decking and underlayment.
3:46	Slight discolouration behind brand on decking.
4:28	Flaming beyond deck extents underneath decking.
6:14	Smoke escaping from horizontal joint on underside.
7:25	Brand approximately 80% consumed.
8:50	Increase in amount of smoke escaping from underside.
9:30	Increase in flaming beneath decking.
13:26	Brand almost completely consumed.
14:30	Increase in smoke from underside.
16:00	Charring on underside along horizontal and vertical joint.
18:40	Brand completely consumed. "crater-like" hole formed in brand's place.
19:21	Flaming and smoke continues on surface and beneath decking.
22:30	Increase in charring on underside. Approximately 16 inches in length
24:02	2x2s ignition. Flaming beyond deck extents.
25:03	Flaming on underside. End of test declared.

**Acceptance Level: Sample was unable to achieve class "A" rating – flaming on underside of deck.**
