# DASSOXTR FIRE TEST REPORT

SFM 12-7A-4A TESTING ON EPC-DK20-G2-PP EPIC COGNAC 1 X 6 FUSED BAMBOO DECK BOARDS

J6810.04-121-24-R0

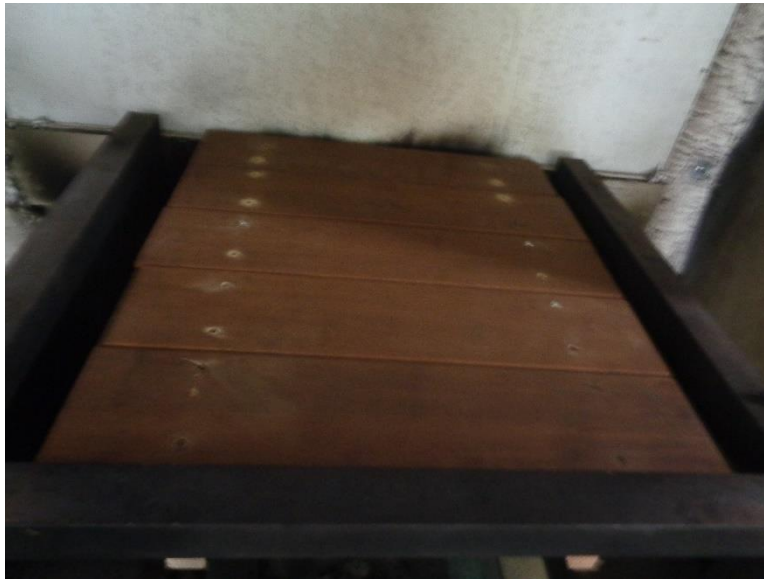
**Photo No. 1**  
**Complete Assembly (Above Deck)**

The overall dimensions of the test assembly are 4 feet wide by 84 inches high. Below is a detailed description of the components in the assembly:

DassoXTR, EPC-DK20-G2-PP Epic Cognac 1 x 6 fused exterior bamboo deck boards were cut to 24 in. long lengths. The deck boards were secured to the joists using Cisen winged deck fasteners system. This system used a #7 x 1-3/5 in. grade 304 stainless steel screws and wing clips to secure the deck boards to the wood joists. The deck fastener system created a 5/16 in. space between each deck board.

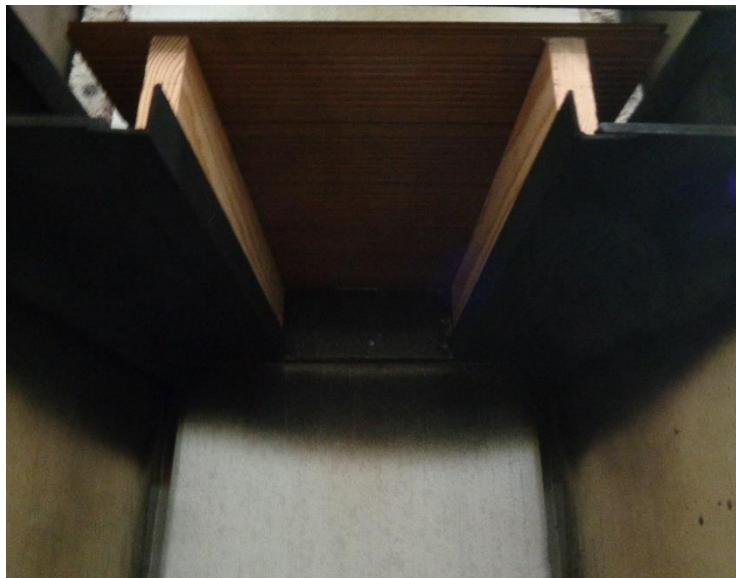
**Photo No. 2**  
**Complete Assembly (Below Deck)**

2 x 6 Douglas fir dimensional lumber was cut to 27-1/8 in. Two identical pieces were cut to simulate two joists for the deck boards to attached to.

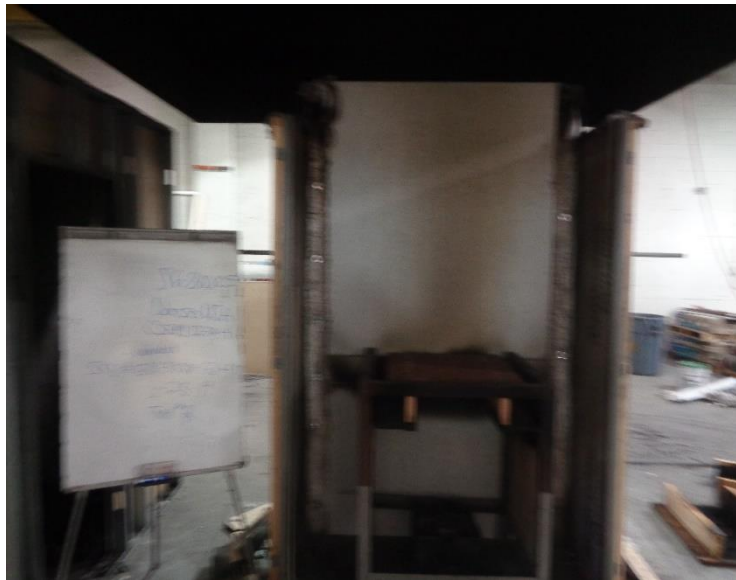
**Photo No. 3**  
**Test Assembly (Pre-test)**

For the under-deck flame test, the ignition source for the under-deck test is a gas burner with a 12 inch by 12 inch diffusion adapter filled with a minimum 4-inch layer of Ottawa sand. The top surface of the burner through which the gas is applied is centered and positioned 27 inches below the surface of the deck. The gas supply to the burner is C.P. grade propane (99 percent purity). A burner verification test is run prior to the under-deck test. Verification test involves using oxygen consumption calorimeter to confirm the output. The burner is set to produce a gross heat output of  $80 \pm 4$  kW for three minutes. The gas burners are controlled with mass flow meters to control the volume of gas to match the heat outputs of the standard. After the verification test, the specimen is installed into the fixture and the diffusion burner is placed. The collection hood exhaust duct blower is turned on and an initial flow is established. Burner is centered underneath the test deck and then ignited at a fuel flow rate that is known to produce 80 kW of heat output and maintained for 3 minutes. When the burner is shut off, post-test observations are documented for 40 minutes.

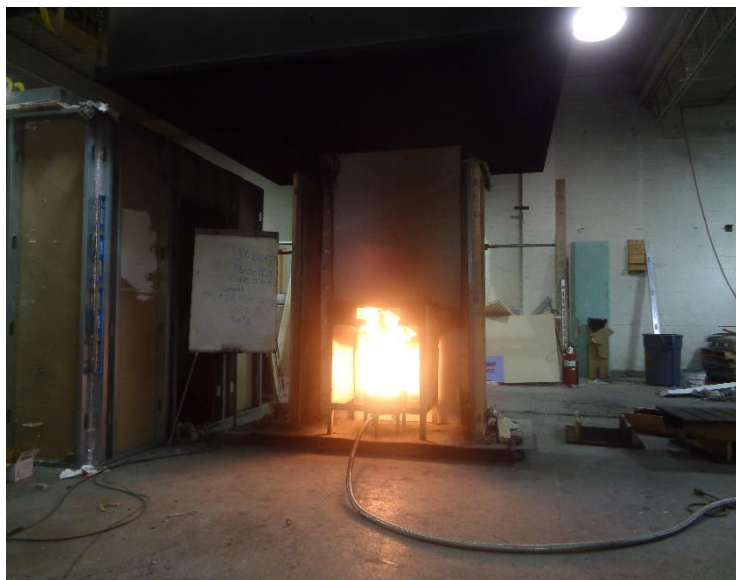
**Photo No. 4**  
**Ignition of Burner**

TIME (Min:Sec)	OBSERVATIONS
00:00	Ignition of burner. Heat output set at 80 kW
00:48	Ignition of the underdeck.
01:04	Ignition of the deck surface.
03:00	Burner extinguished.
04:16	Flaming on the deck surfaces stop emitting from the surfaces.
43:00	End of test and observations.

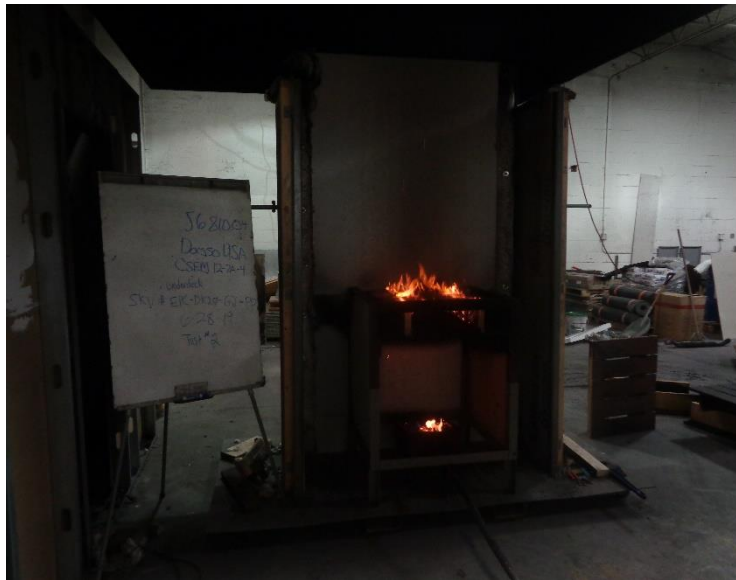
**Photo No. 5  
Burner Off**

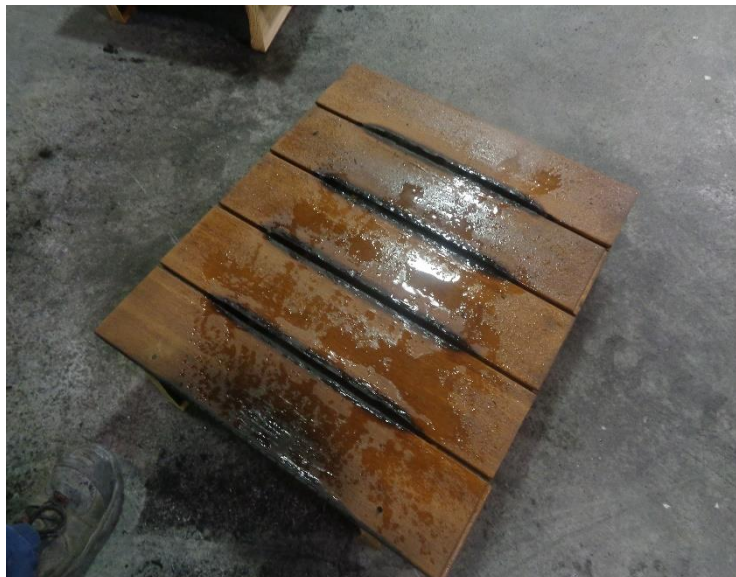
**Photo No. 6  
Post-test Above Deck**

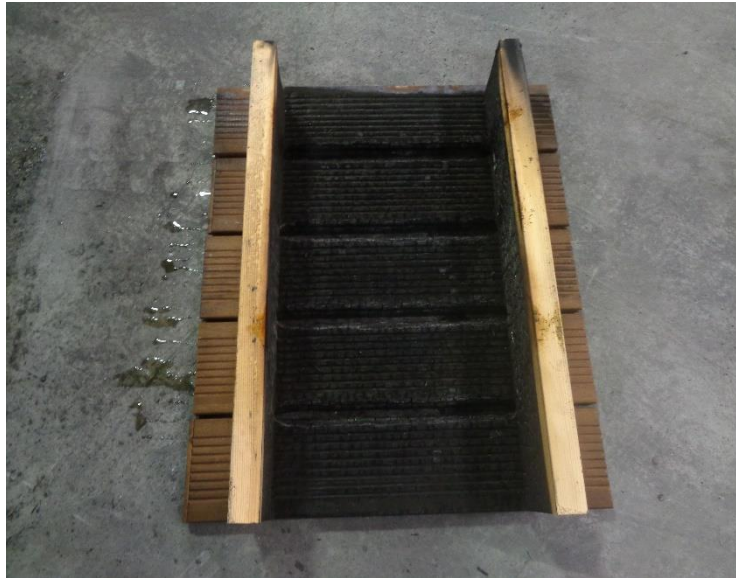
**Photo No. 7**  
**Post-test Below Deck**

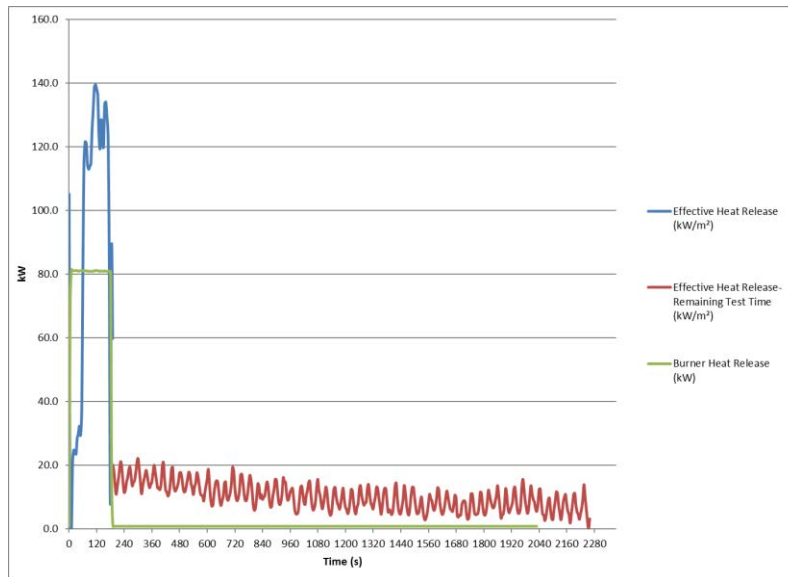
**Graph No. 2**  
**Under-deck Test #1 Heat Release Data**

TEST REQUIREMENTS	TEST RESULTS	PASS/FAIL
Effective net peak heat release rate of less than or equal to 25 kW/ft <sup>2</sup> (269 kW/m <sup>2</sup> )	Effective net peak heat release rate of: Sample #1: 158.1 kW/m <sup>2</sup> Sample #2: 137.8 kW/m <sup>2</sup> Sample #3: 150.3 kW/m <sup>2</sup>	<b>PASS</b>

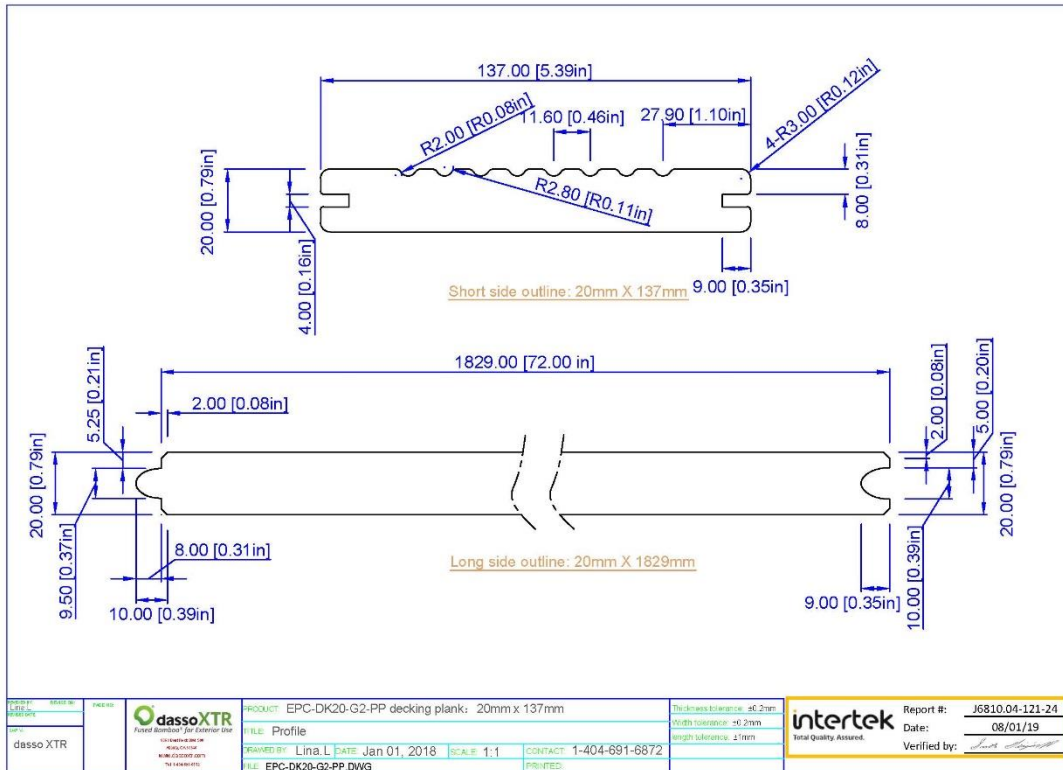
DRAWN BY: CHECKED BY: dasso XTR	 Fixed dimension for exterior use	PRODUCT: EPC-DK20-G2-PP decking plank: 20mm x 137mm FILE: Profile DRAWN BY: Lina L DATE: Jan 01, 2018 SCALE: 1:1 CONTACT: 1-404-691-6872 FILE: EPC-DK20-G2-PP.DWG	Thickness tolerance: +0.2mm Width tolerance: +0.2mm Length tolerance: ±1mm	 Total Quality Assured.	Report #: J6810.04-121-24 Date: 08/01/19 Verified by:
---------------------------------------	--------------------------------------	--	--	----------------------------	---

The test specimen drawings which follow have been reviewed by Intertek B&C and are representative of the test specimen(s) reported herein. Test specimen construction was verified by Intertek B&C per the drawings included in this report. Any deviations are documented herein or on the drawings.
